MASSACHUSETTS COASTAL AREA
WESTON, MASSACHUSETTS

NORUMBEGA RESERVOIR DAM AND DIKES
NORUMBEGA RESERVOIR DAM AND EAST DIKE MA 00782
DIKE 2 AND DIKE 3 _____ MA 01208
DIKE 4 _____ MA 01209

**PHASE I INSPECTION REPORT
NATIONAL DAM INSPECTION PROGRAM**

MARCH 1980

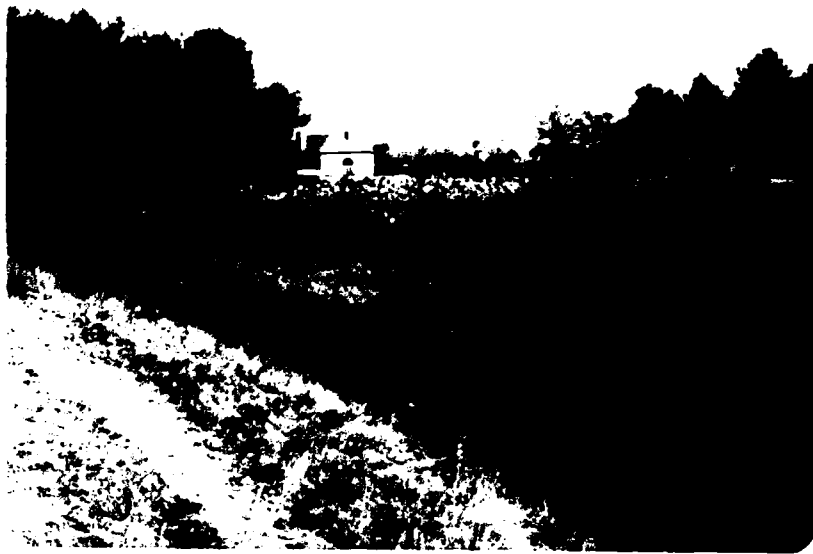
The east dike is zoned earth embankment about 1,200 feet long and about 10 feet in height with a roadway on the crest, photographs 14 and 15. Trees and brush were observed growing through the riprap on the upstream slope. The crest of the dike was covered with grass and gravel and showed no signs of cracking or misalignment that could be attributed to embankment movement. The downstream slope was covered with brush growth and showed no signs of seepage.

PHOTO NO. 15 - General view of East Dike looking
toward gatehouse.
